HYDRO-TRIAD, LTD

NATIONAL WESTERN STOCK SHOW
ENVIRONMENTAL ASSESSMENT REVIEW

PHASE II

March, 1991

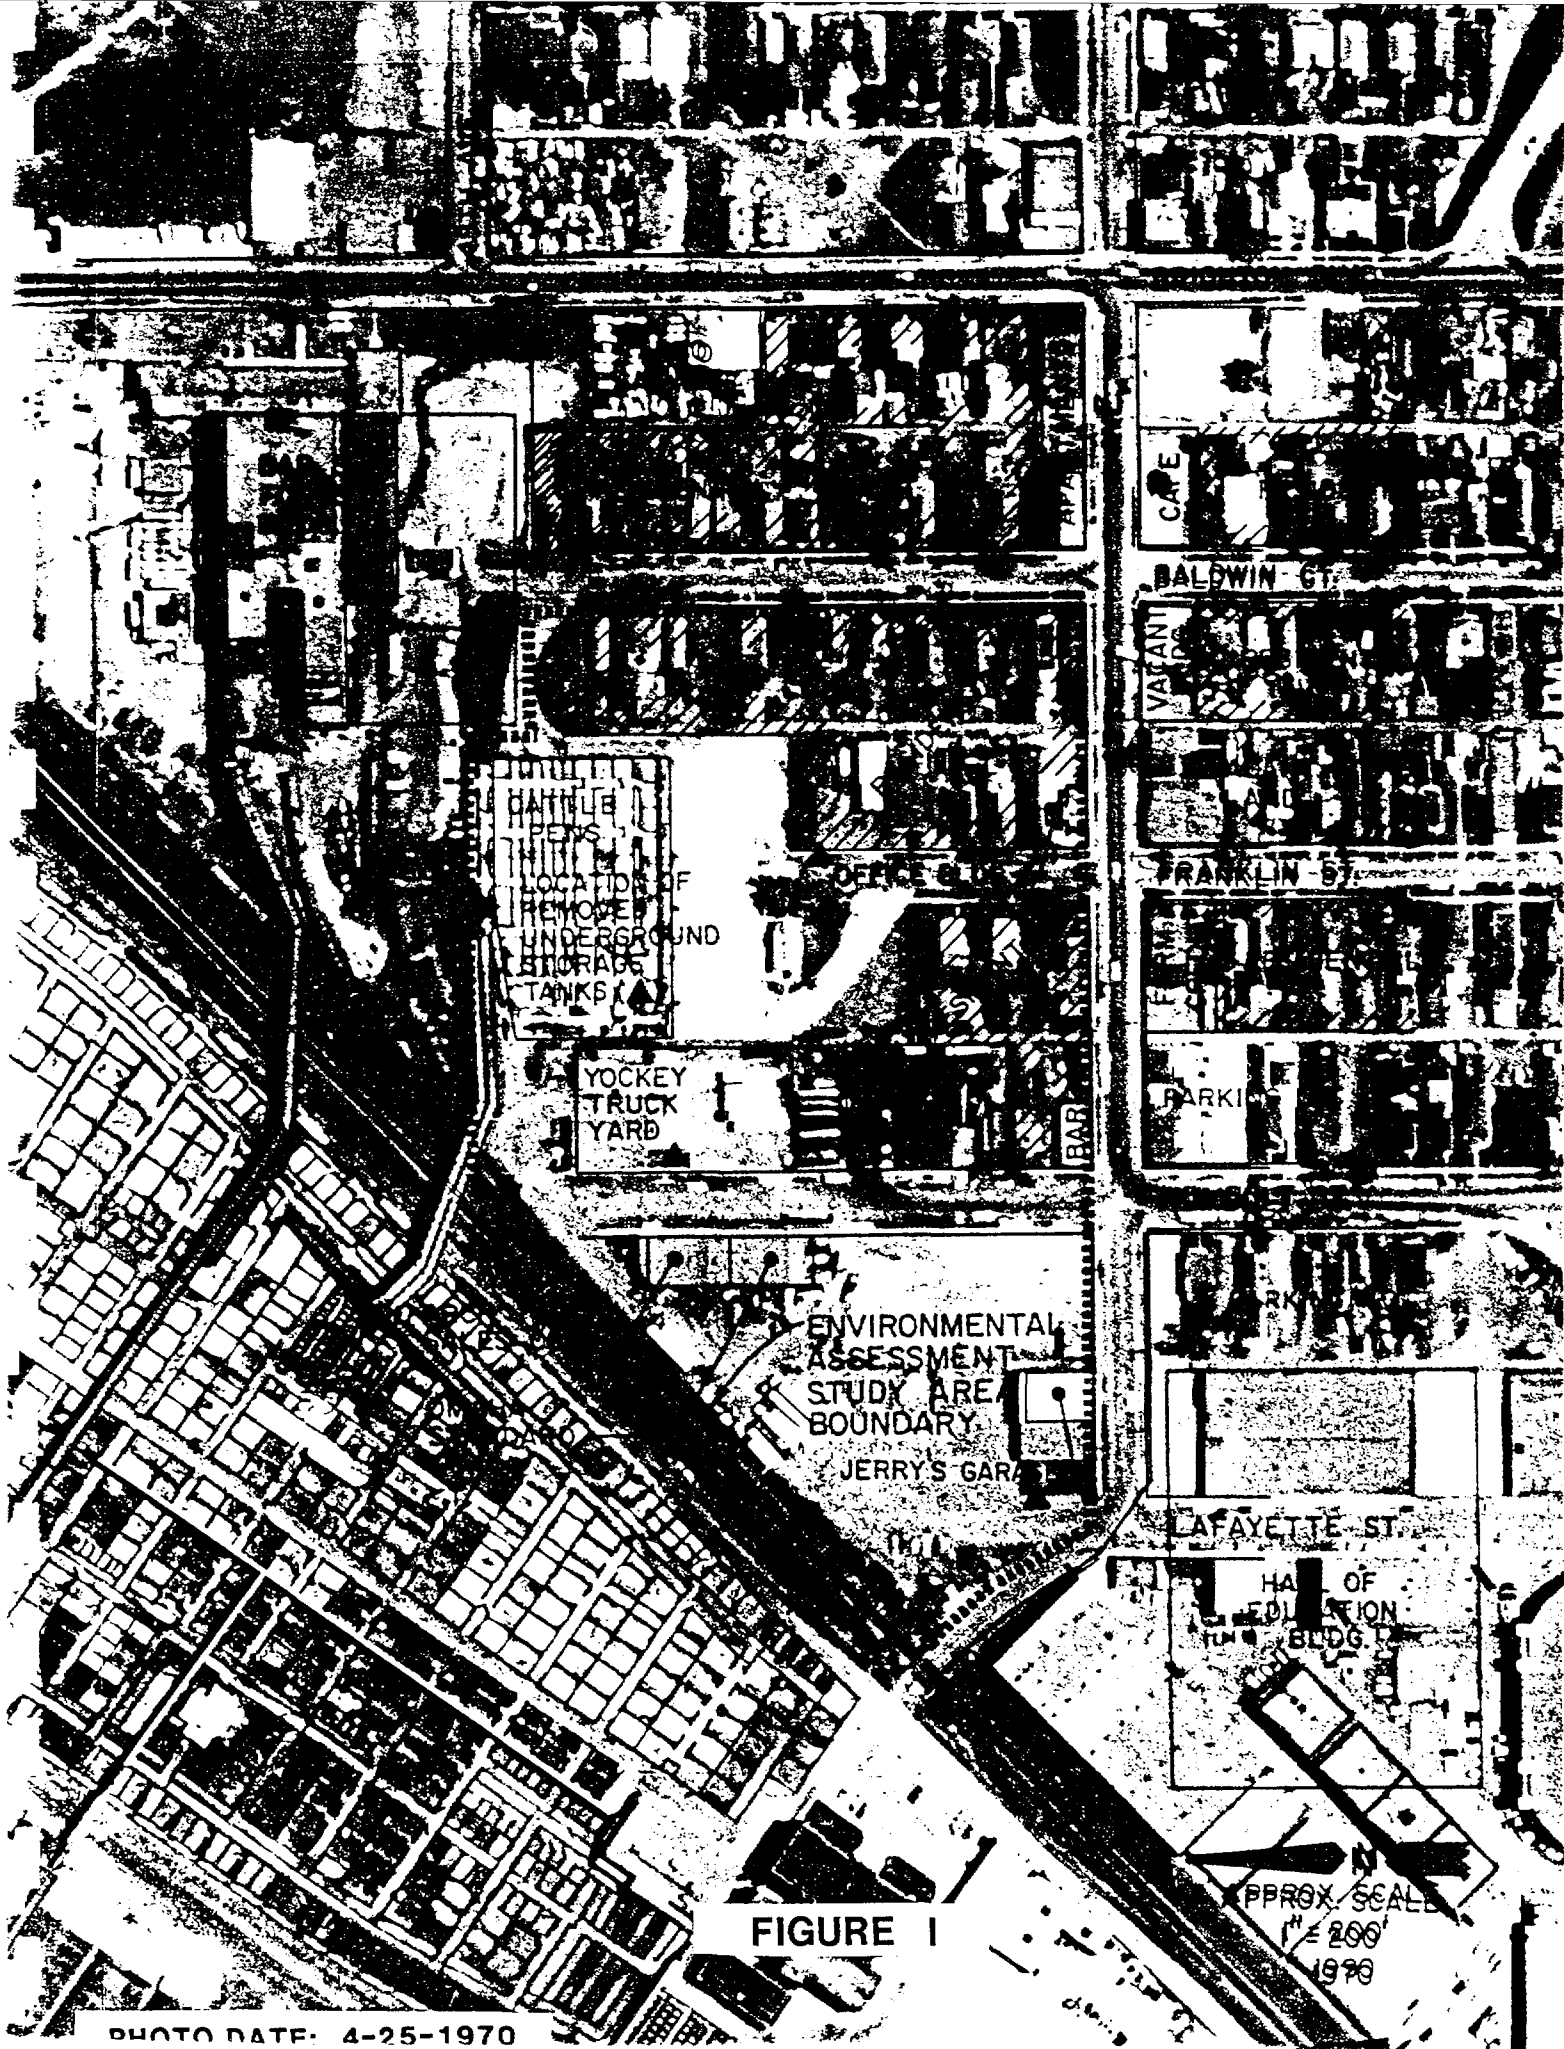
FIGURE I

The historic uses for the study area are shown on Figure 1. Figure 1 is a 1970 photograph which was selected because it was a good representation of past uses prior to the recent demolition activities. The identification of past uses was based on personal communications with Larry (Cookie) Perry, a 30-year

employee of the Stock Show and a review of historic aerial photographs. The past uses of the property are indicated on the Figure 1, 1970 overlay.

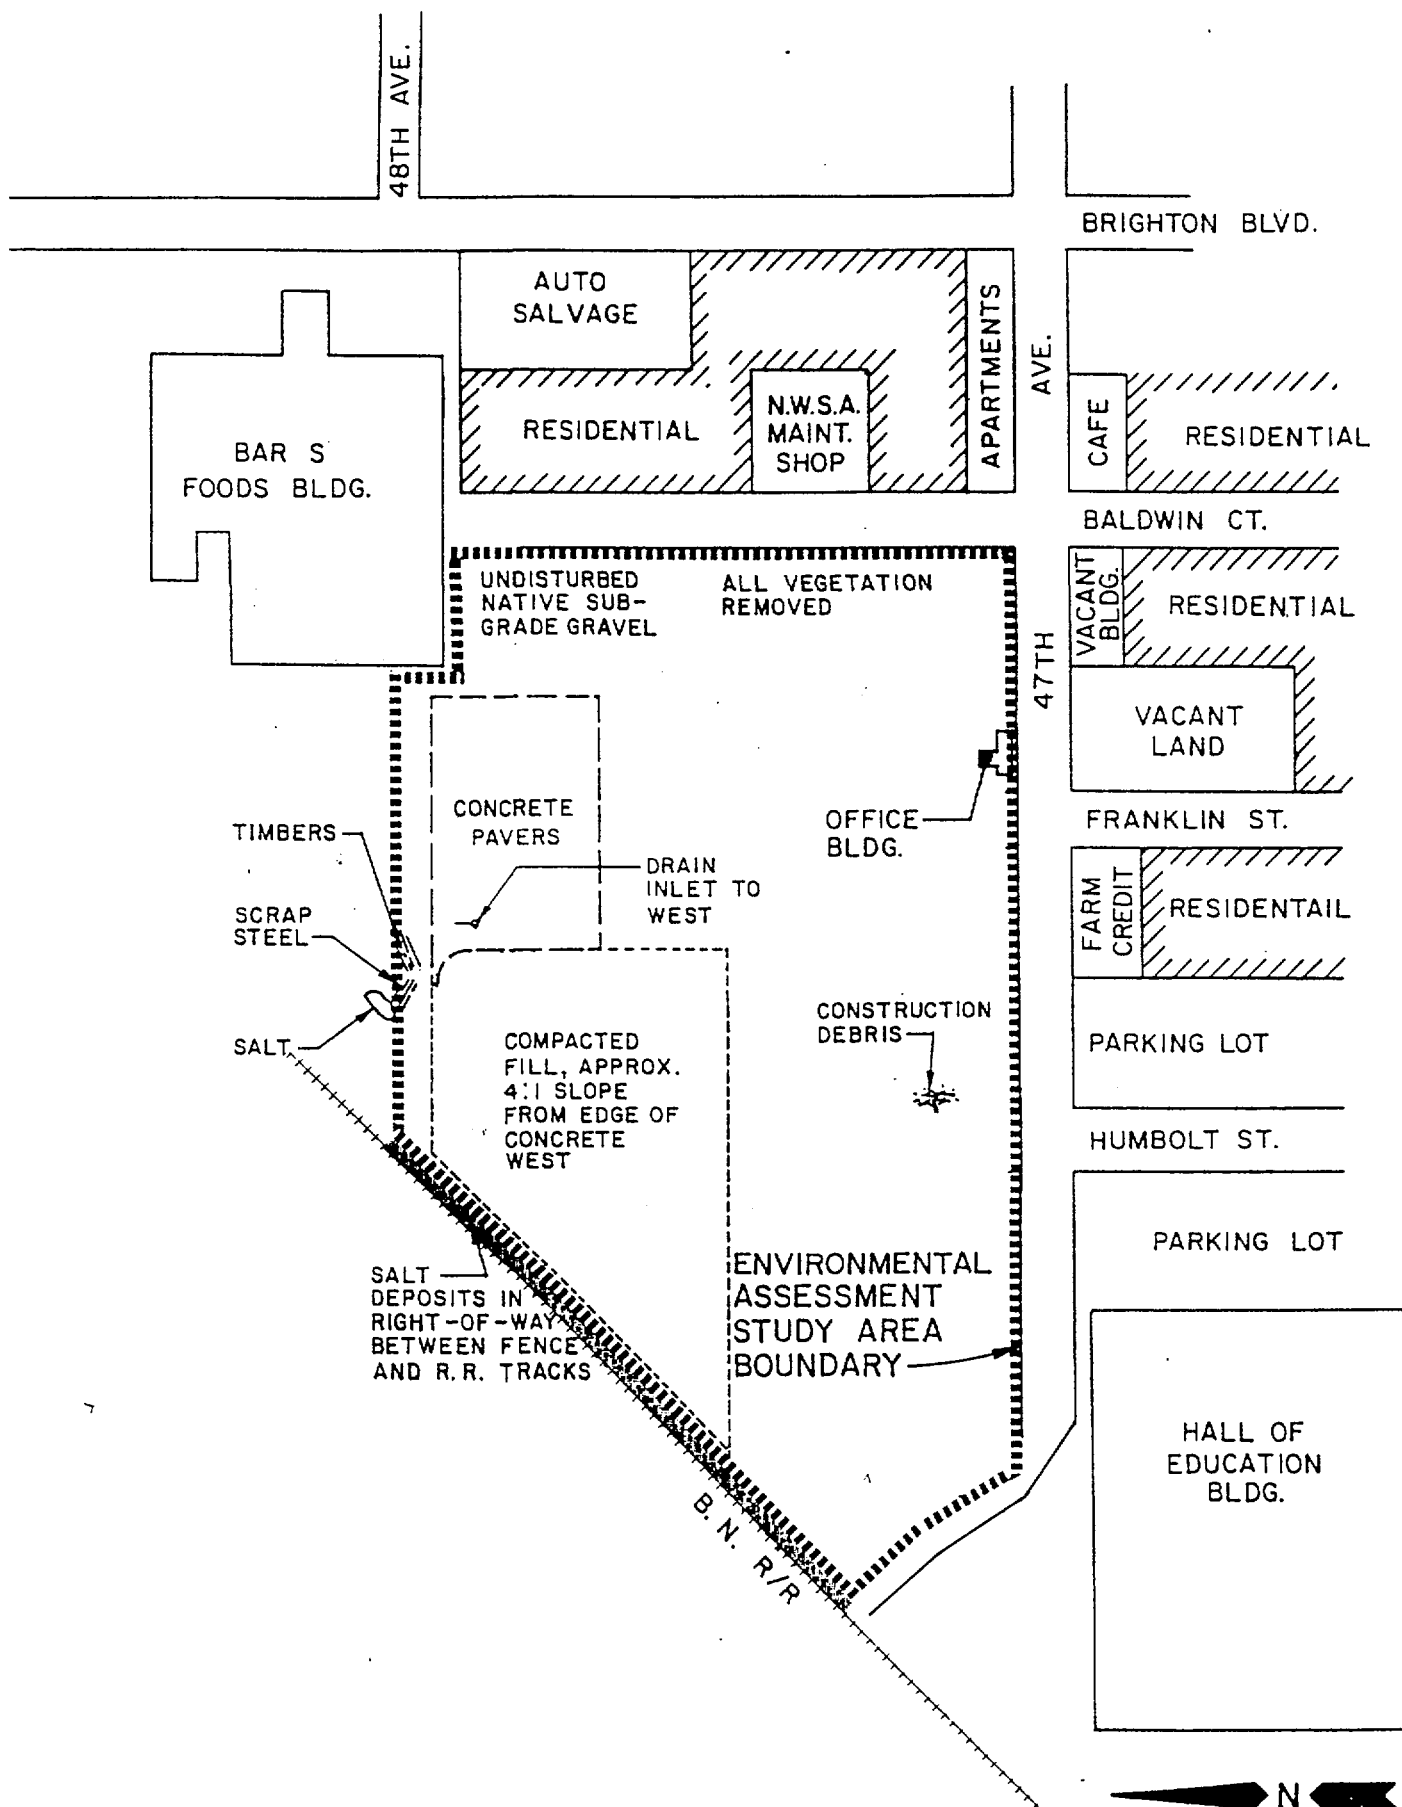
FIGURE II

An inspection of the site was conducted by Hydro-Triad personnel on November 1, 1990. The existing condition of the site resembles an undeveloped area because almost all of the previous structures have been demolished. One house, which serves as an office, still exists northeast of the intersection of 47th Avenue and Franklin Street. The present features of the site are identified on Figure 2.

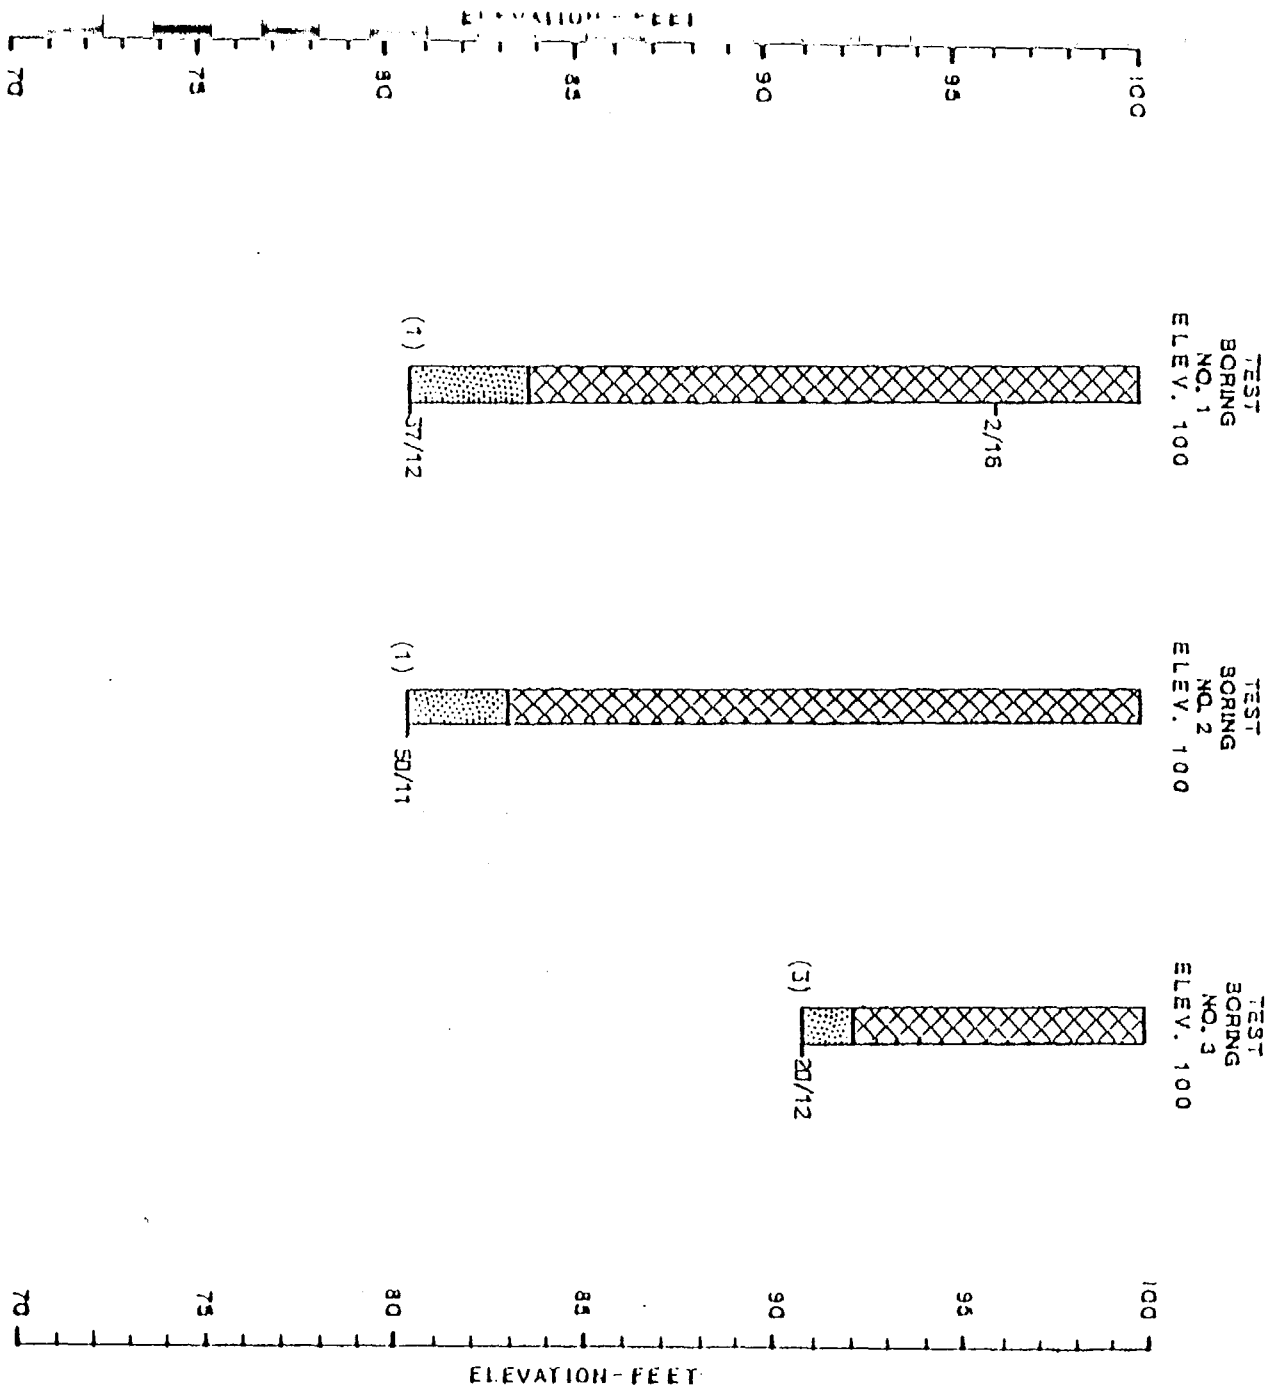
LOGS OF EXPLORATORY BORINGS
FIGURE 2

Test Borings TB-1 and TB-2 indicate the subsoils in general consist of 11 feet of man-placed, very loose, sand with some concrete debris, overlying a dense gravelly sand. One soil sample was obtained from each test boring at a depth of 14 feet. The two soil samples were mixed in a stainless steel bucket, and one sample labeled TB-1/TB-2 was obtained and submitted to Evergreen Analytical Inc. (EAI), Wheat Ridge, Colorado, for analysis.

Test Boring TB-3 indicated the subsoils consist of 8 feet of man-placed, very loose sand, with some concrete debris overlying a dense, gravelly sand. One soil sample was obtained from the test boring at 9 feet of depth and submitted to EAI for analysis. A more complete description of the subsoils is shown on Figure 2.

AGW would recommend no further action be taken at this site with regard to soil testing. This report should be submitted to the CDH Underground Storage Tank Division as part of final closure requirements.

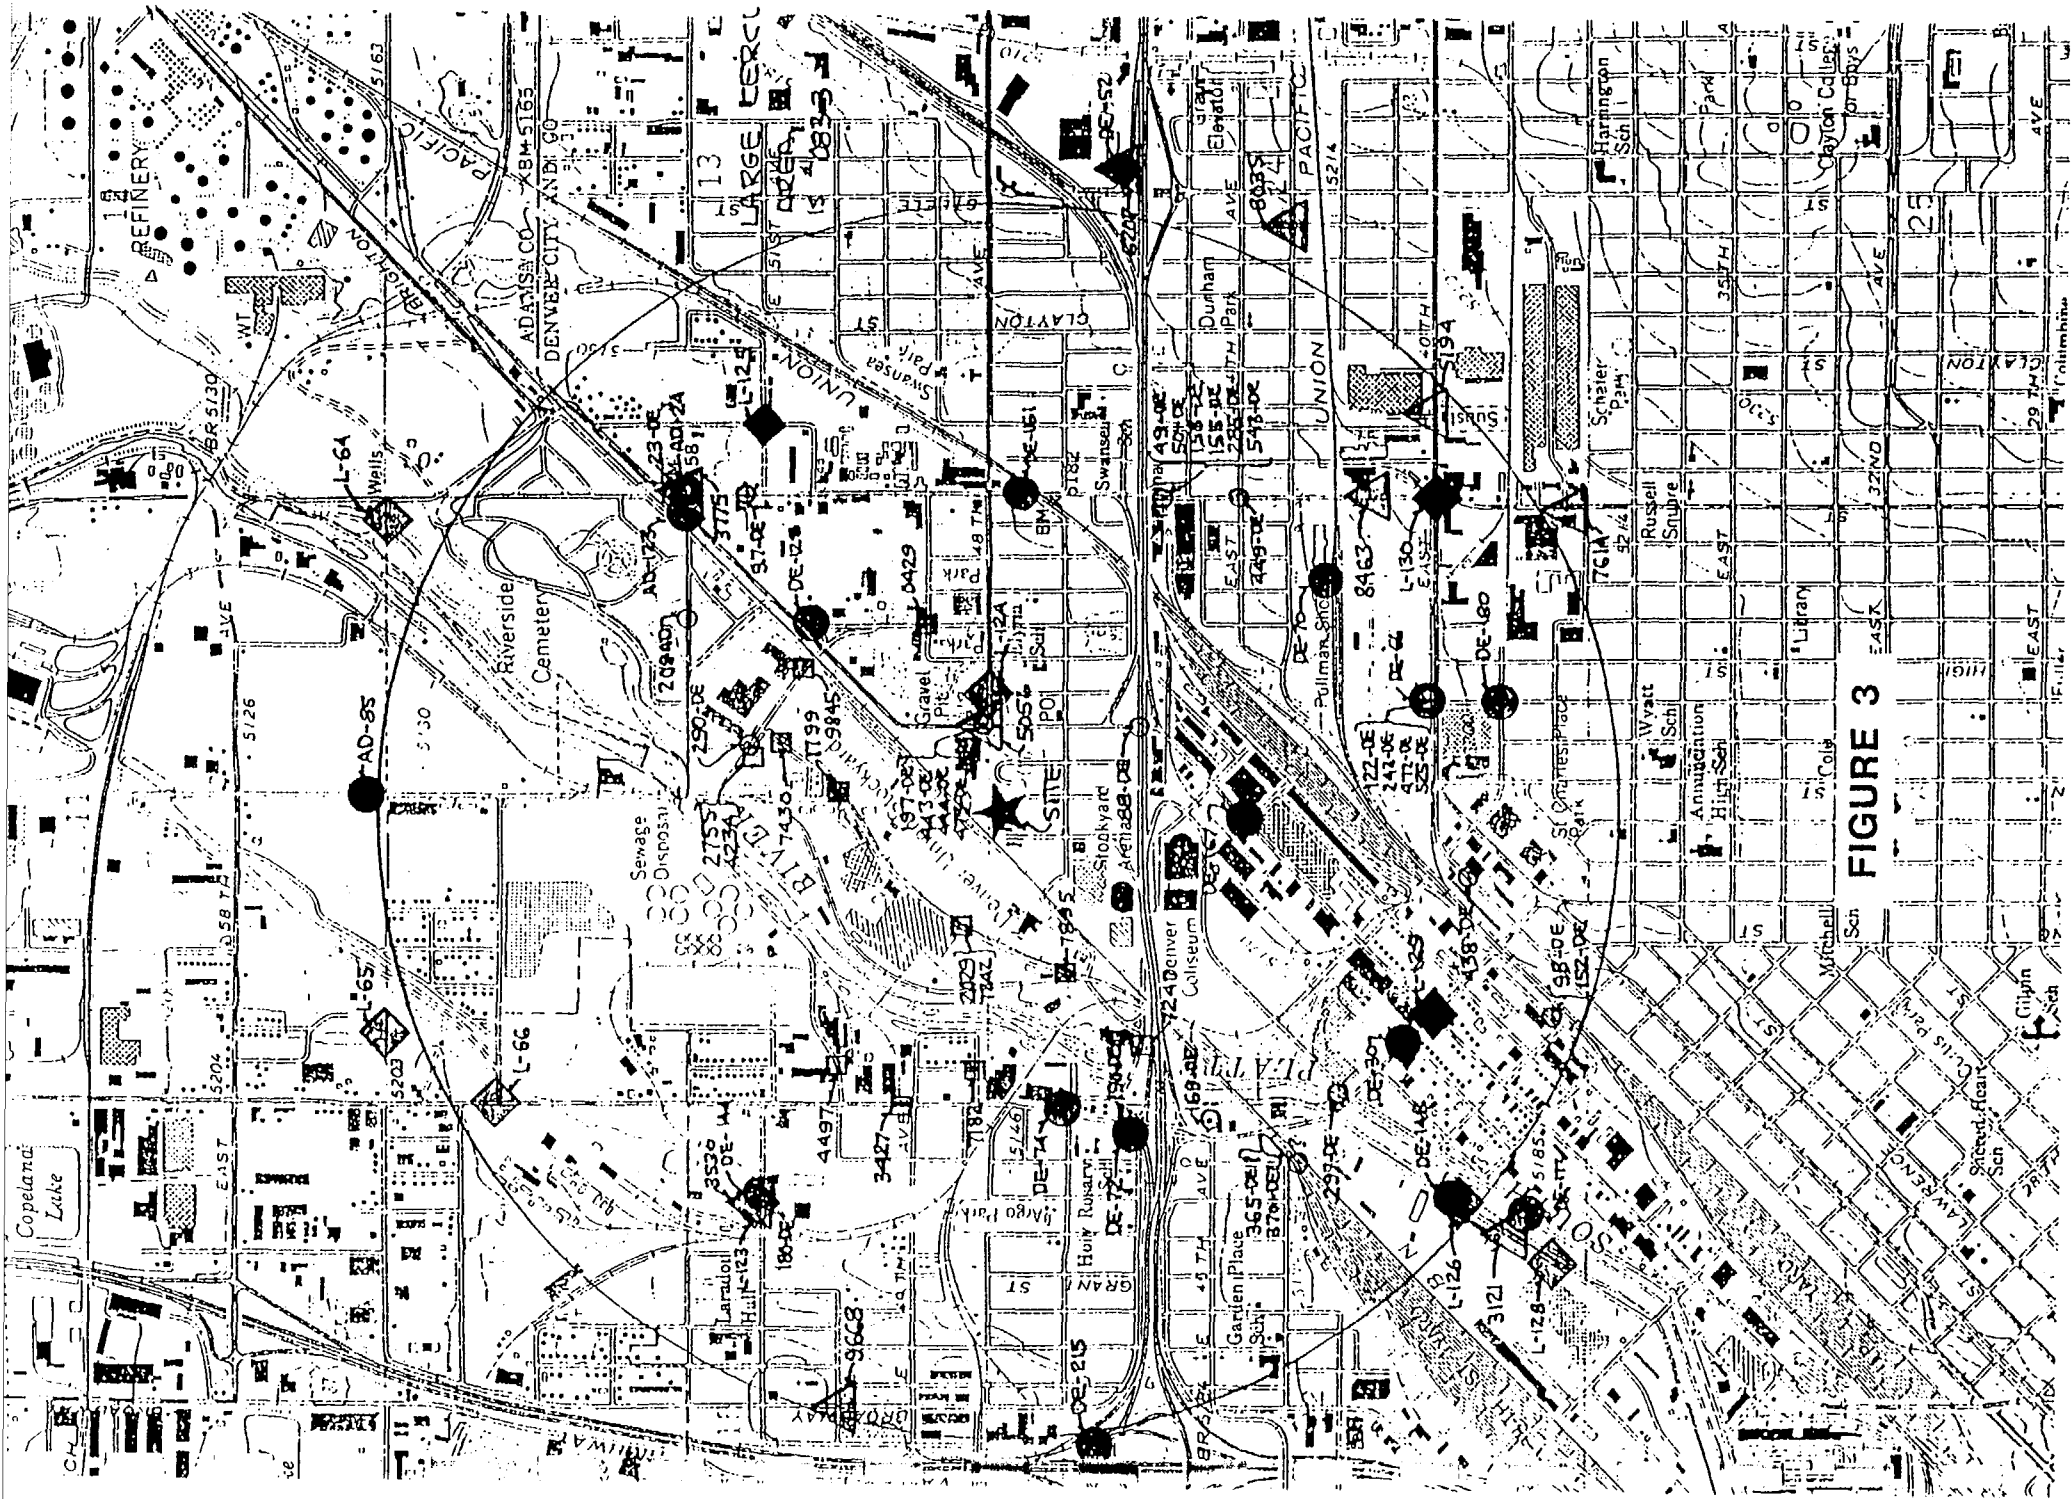
FIGURE 3

The locations for these occurrences is shown on Figure 3. The reports are included as Attachment E. The RCRA Generator/TSD Facilities were only plotted within 0.5 miles because there were so many of them. There were 13 facilities located within the 0.5 mile range.

The occurrences of significance are those within a close proximity to the site, especially the ones to the southeast. The southeast area should be considered upgradient because the direction of ground water flow is probably to the northwest, towards the Platte River. This assumption is substantiated by Industrial Compliance, Inc which is conducting an environmental assessment of an underground storage tank leak in an area southwest of Phase 2.
